**Flood Control Project Maintenance
Levee Inspections
LMA District Cover Sheet
Spring 2010 Levee Inspection Results**

San Joaquin County Flood Control and Water Conservation District

Spring 2010 Levee Inspection Results

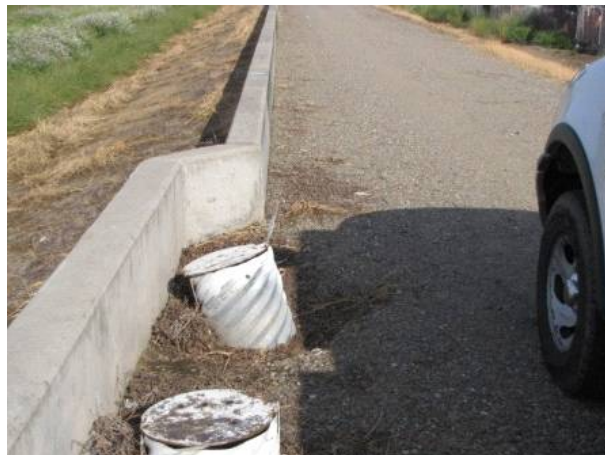
dpesaven_s_20100518_587.jpg

Levee Mile Report Line	152
Start Levee Mile	17.00
End Levee Mile	17.00
Location	Crown
Category	Earthen Levee
Item	Crown Surface / Depressions / Rutting

View of a depression on the waterward side of the crown around a siphon breaker looking downstream.

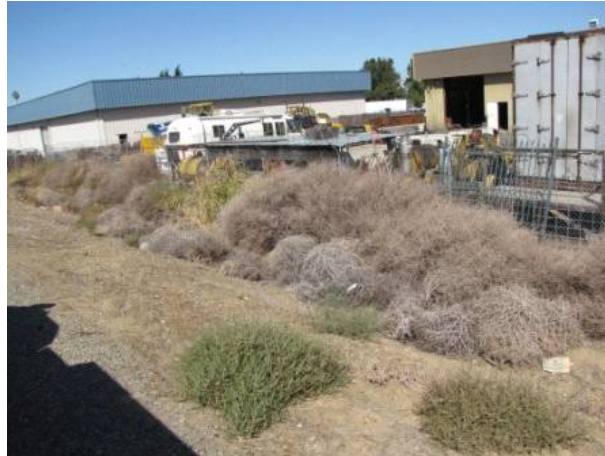
dpesaven_s_20100316_316.jpg

View of vegetation blocking visibility and access along the landward toe looking downstream.

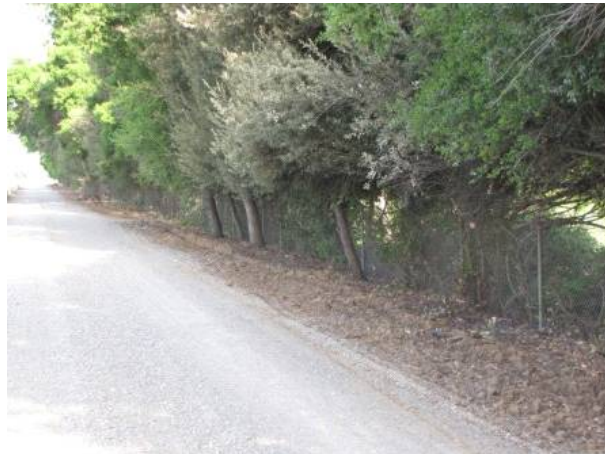
dpesaven_s_20100518_588.jpg

Levee Mile Report Line	156
Start Levee Mile	17.83
End Levee Mile	18.02
Location	Land Side
Category	Earthen Levee
Item	Encroachments

View of tilling done on the landward shoulder of the levee looking downstream.

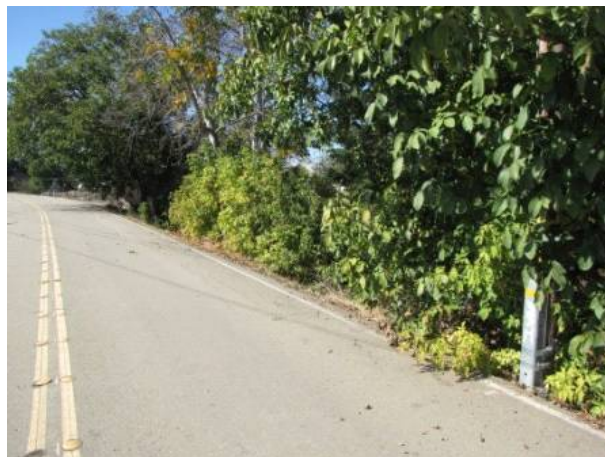
dpesaven_s_20100316_320.jpg

Levee Mile Report Line	165
Start Levee Mile	18.54
End Levee Mile	18.55
Location	Land Side
Category	Earthen Levee
Item	Encroachments

View of landowner planted and maintained vegetation along the landward slope looking downstream.

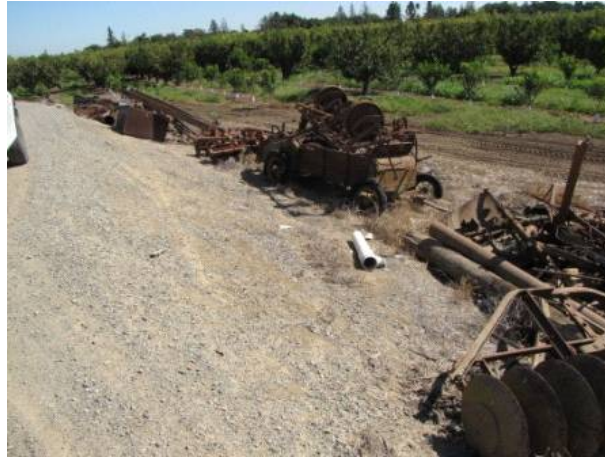
dpesaven_s_20100316_319.jpg

View of equipment on the landward slope and toe looking downstream.

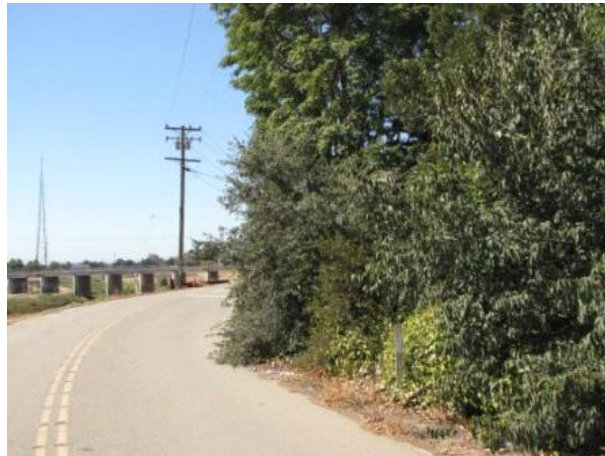
dpesaven_s_20100316_322.jpg

Levee Mile Report Line	171
Start Levee Mile	19.80
End Levee Mile	19.86
Location	Land Side
Category	Earthen Levee
Item	Encroachments

View of landowner planted and maintained vegetation along the landward slope looking downstream.

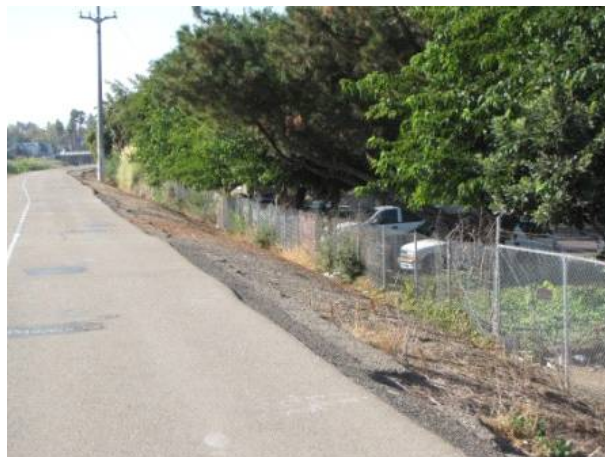
dpesaven_s_20100316_329.jpg

Levee Mile Report Line	185
Start Levee Mile	21.46
End Levee Mile	21.61
Location	Land Side
Category	Earthen Levee
Item	Encroachments

View of fence along the landward toe looking downstream.

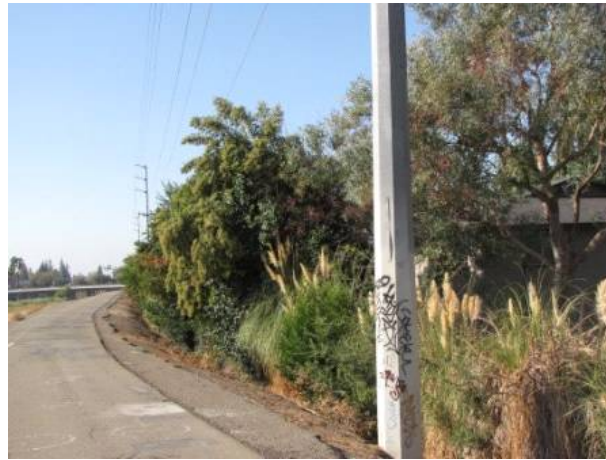
dpesaven_s_20100316_259.jpg

View of landscaping along the landward slope and toe looking downstream.

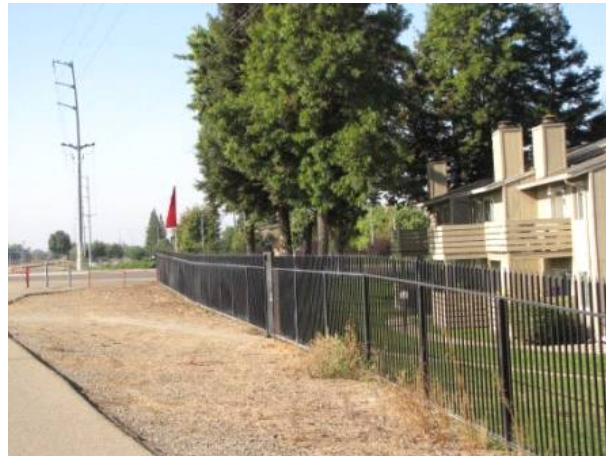
dpesaven_s_20100316_330.jpg

Levee Mile Report Line	187
Start Levee Mile	21.73
End Levee Mile	21.77
Location	Land Side
Category	Earthen Levee
Item	Encroachments

View of fence along the landward shoulder looking downstream.

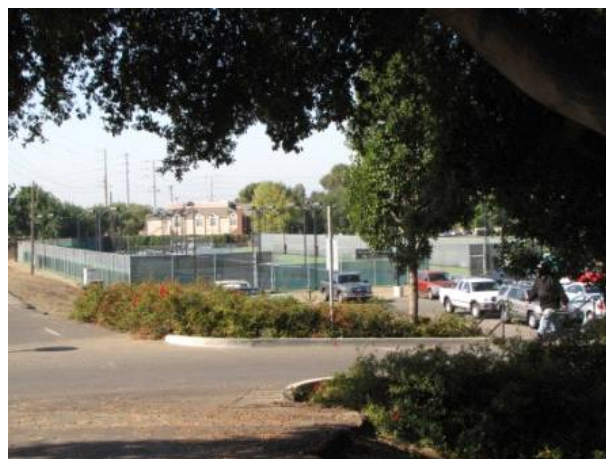
dpesaven_s_20100316_332.jpg

Levee Mile Report Line	190
Start Levee Mile	22.11
End Levee Mile	22.11
Location	Land Side
Category	Earthen Levee
Item	Encroachments

View of landscaping maintained by UOP along the landward slope looking downstream.

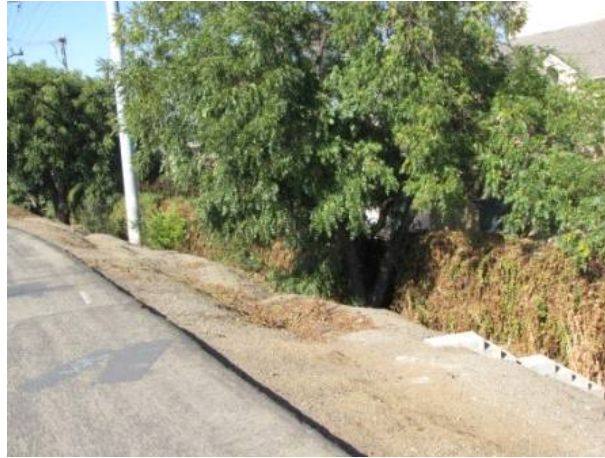
dpesaven_s_20100316_260.jpg

View of landscaping along the landward toe of the levee looking downstream.

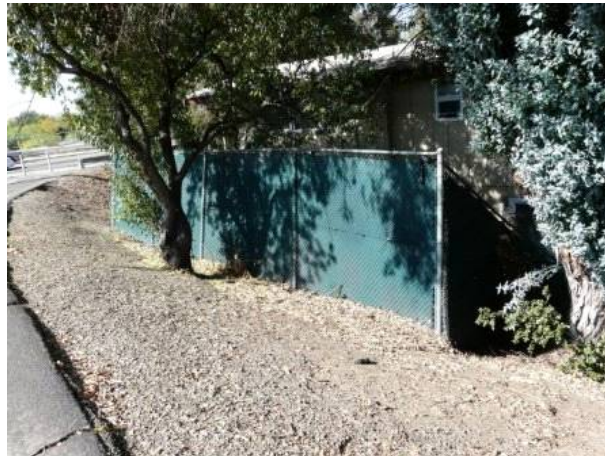
dpesaven_s_20100316_270.JPG

Levee Mile Report Line	192
Start Levee Mile	22.36
End Levee Mile	22.37
Location	Land Side
Category	Earthen Levee
Item	Encroachments

Fence located from LM 22.36 to LM 22.37 significantly encroaches onto landside levee slope.

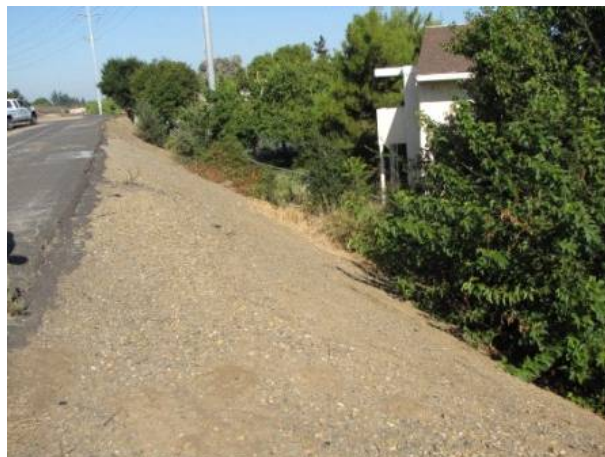
dpesaven_s_20100316_333.jpg

Levee Mile Report Line	193
Start Levee Mile	22.40
End Levee Mile	22.43
Location	Land Side
Category	Earthen Levee
Item	Vegetation

View of vegetation blocking visibility and access along the landward slope and toe looking downstream.

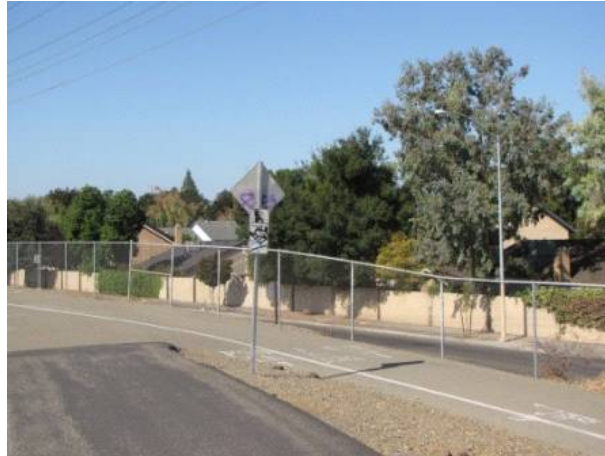
dpesaven_s_20100316_334.jpg

View of fence along the landward shoulder looking downstream.

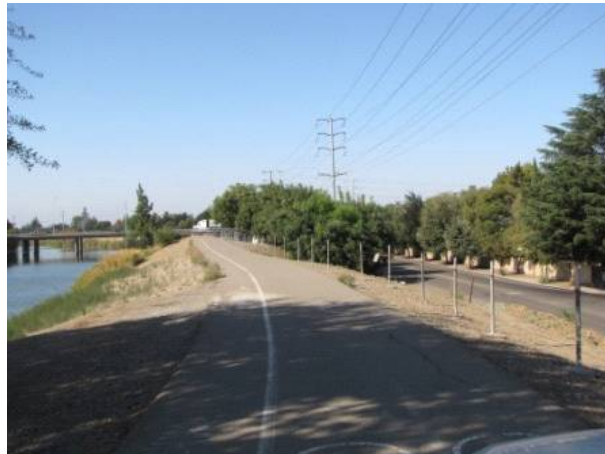
dpesaven_s_20100316_335.jpg

Levee Mile Report Line	197
Start Levee Mile	23.54
End Levee Mile	23.69
Location	Land Side
Category	Earthen Levee
Item	Encroachments

View of fence along landward shoulder looking downstream.

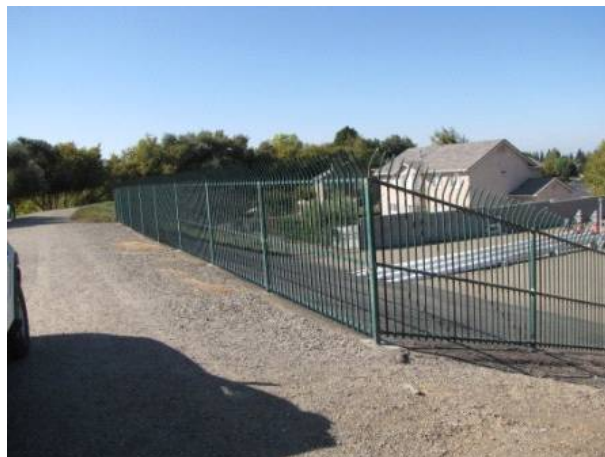
dpesaven_s_20100316_337.jpg

Levee Mile Report Line	199
Start Levee Mile	24.20
End Levee Mile	24.21
Location	Land Side
Category	Earthen Levee
Item	Encroachments

View of fence along the landward shoulder looking downstream.

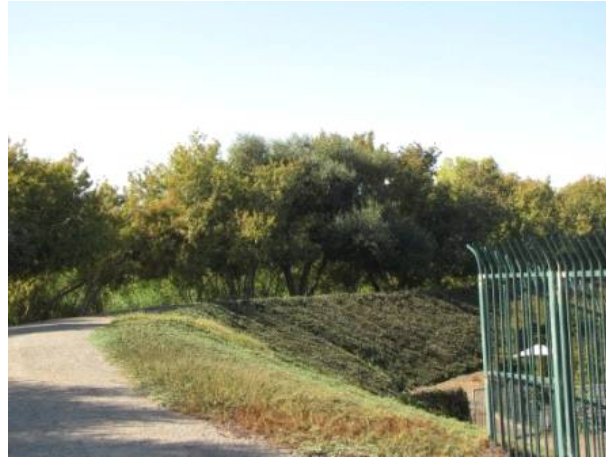
dpesaven_s_20100316_261.jpg

View of typical landowner planted and maintained landscaping and irrigation along the landward shoulder, and toe looking downstream.

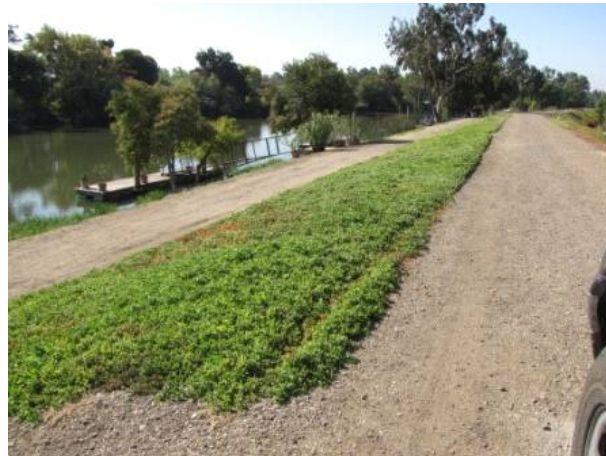
dpesaven_s_20100316_338.jpg

Levee Mile Report Line	201
Start Levee Mile	24.65
End Levee Mile	25.59
Location	Water Side
Category	Earthen Levee
Item	Encroachments

View of typical landowner planted and maintained landscaping and irrigation along the waterward shoulder and slope looking downstream.

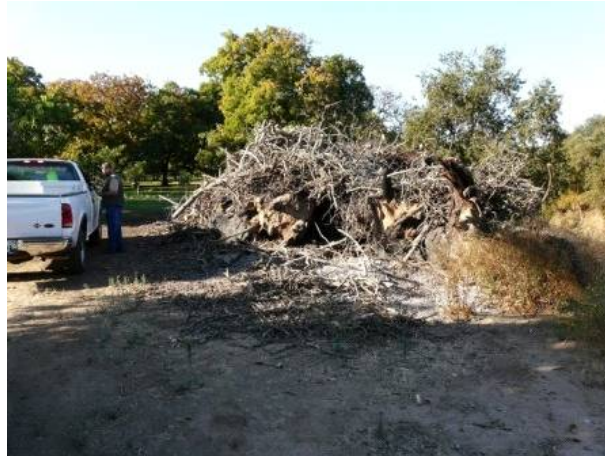
13	3.35	3.35	Earthen Levee	Encroachments	WS	M	Prunings Inspector Comments: Burn pile has been burned but new material has been placed.	38.023257 ° -121.058158 °	38.023257 ° -121.058158 °	52
14	3.52	3.52	Earthen Levee	Encroachments	WS	M	Prunings Inspector Comments: Burn pile has been burned but new material has been placed.	38.021650 ° -121.060312 °	38.021650 ° -121.060312 °	53
15	3.78	3.78	Earthen Levee	Encroachments	WS	M	Prunings Inspector Comments: Burn pile has been burned but it is a site of habitual use and there is leftover material. Raymond's pile has been removed.	38.018975 ° -121.063469 °	38.018975 ° -121.063469 °	54 Y

Levee Mile Report Line	1
Start Levee Mile	0.32
End Levee Mile	0.32
Location	Crown
Category	Earthen Levee
Item	Encroachments
Prunings pile located at LM 0.32 on waterside shoulder of access road. The pile impedes access and forces vehicles to drive through orchard.	
dpesaven_s_20100316_339.JPG

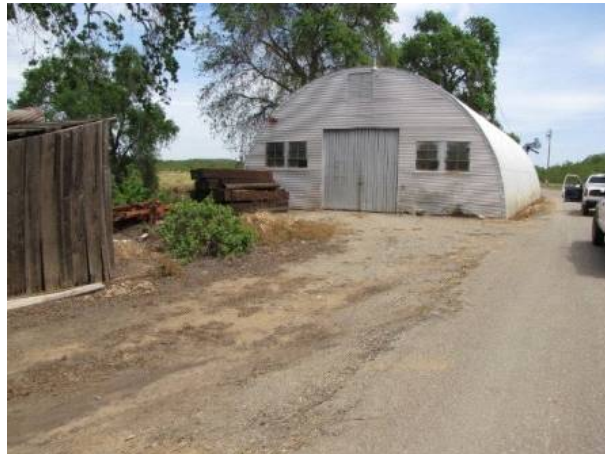
Levee Mile Report Line	2
Start Levee Mile	0.54
End Levee Mile	0.54
Location	Water Side
Category	Earthen Levee
Item	Encroachments
Building/shed and other equipment located on waterward side of access road. There is no vehicle access adjacent to the channel.	
dpesaven_s_20100316_347.jpg

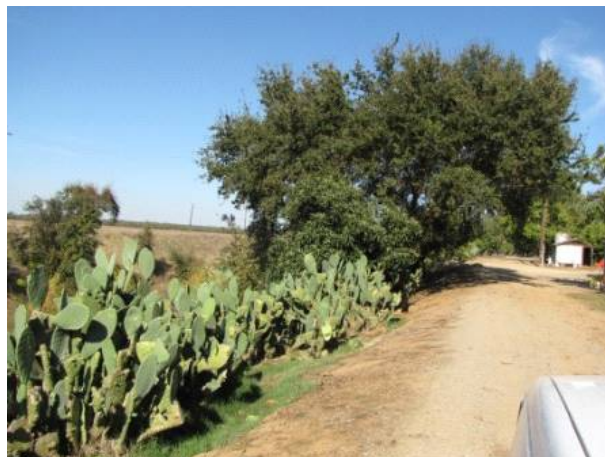
Levee Mile Report Line	5
Start Levee Mile	0.83
End Levee Mile	0.89
Location	Water Side
Category	Earthen Levee
Item	Encroachments
View of landowner maintained landscaping on waterward side looking upstream.	
dpesaven_s_20100316_420.jpg

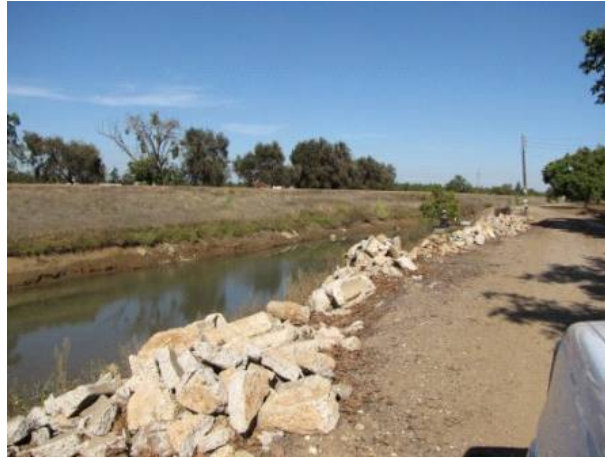
dpesaven_s_20100316_418.jpg

View of concrete debris on waterward side looking upstream.

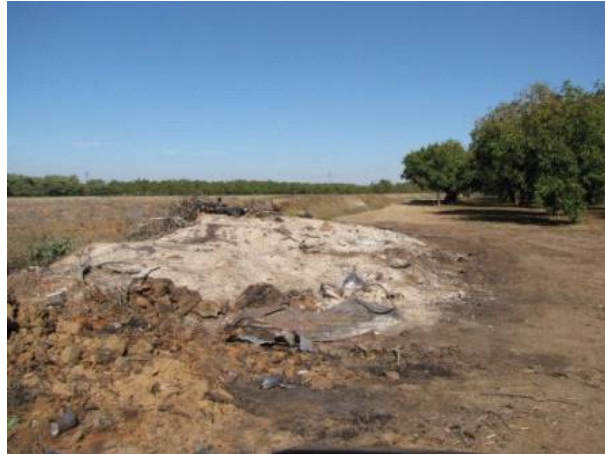
dpesaven_s_20100316_340.jpg

Levee Mile Report Line	15
Start Levee Mile	3.78
End Levee Mile	3.78
Location	Water Side
Category	Earthen Levee
Item	Encroachments

View of burn pile that has been burned and a location where a landowner recently removed prunings as requested looking upstream.

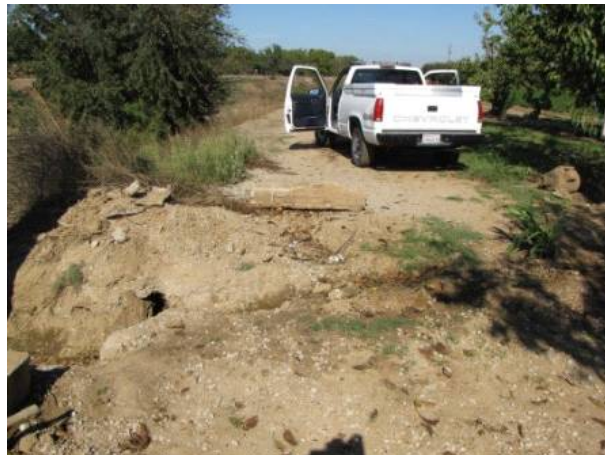
dpesaven_s_20100316_417.jpg

Levee Mile Report Line	16
Start Levee Mile	4.31
End Levee Mile	4.31
Location	Crown
Category	Earthen Levee
Item	Crown Surface / Depressions / Rutting

View of recent construction that has left the access road damaged looking upstream.

LMR No	Levee Mile		Category	Item	Location	Rating	Action/Comment	GPS Latitude/Longitude		Issue No.
	Start	End						Start	End	
16	4.31	4.31	Earthen Levee	Crown Surface / Depressions / Rutting	CR	M	Regrade the crown roadway for proper drainage. Inspector Comments: A recent pipe replacement has left the crown roadway damaged.	38.012662 ° -121.068080 °	38.012662 ° -121.068080 °	176 Y
17	4.45	4.45	Earthen Levee	Erosion / Bank Caving	WS	C	Note and monitor erosion site.	38.010825 ° -121.068716 °	38.010825 ° -121.068716 °	175
18	4.56	4.58	Supplemental	DWR Erosion Survey	WS	M	Inspector Comments: 2009: Differential settlement of 1-2'; appears to be a shallow slide caused by undercutting; settlement has carved into the crown; adjacent area was recently repaired for burrow den on the lower slope; recently placed rocks on adjacent repair site [2009 SiteID:NA0017U16RM4.57]	38.009201 ° -121.069224 °	38.009201 ° -121.069224 °	42 Y

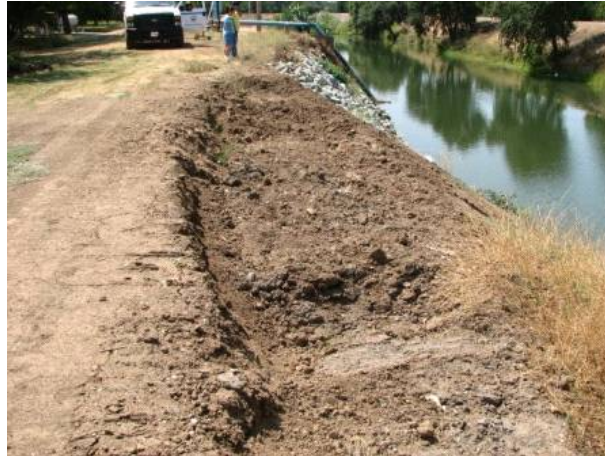
SJR2009_LM4.57U16 081209A.JPG

2009: Differential settlement of 1-2"; appears to be a shallow slide caused by undercutting; settlement has carved into the crown; adjacent area was recently repaired for burrow den on the lower slope; recently placed rocks on adjacent repair site [2009 SiteID:NA0017U16RM4.57]

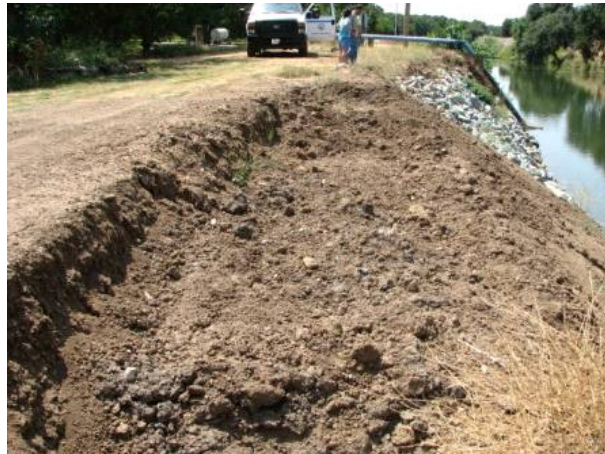
SJR2009_LM4.57U16 081209B.JPG

Levee Mile Report Line	18
Start Levee Mile	4.56
End Levee Mile	4.58
Location	Water Side
Category	Supplemental
Item	DWR Erosion Survey

2009: Differential settlement of 1-2"; appears to be a shallow slide caused by undercutting; settlement has carved into the crown; adjacent area was recently repaired for burrow den on the lower slope; recently placed rocks on adjacent repair site [2009 SiteID:NA0017U16RM4.57]

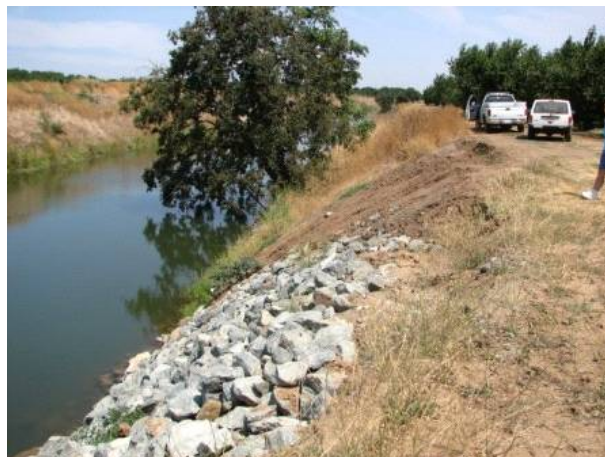
SJR2009_LM4.57U16 081209C.JPG

Levee Mile Report Line	18
Start Levee Mile	4.56
End Levee Mile	4.58
Location	Water Side
Category	Supplemental
Item	DWR Erosion Survey

2009: Differential settlement of 1-2"; appears to be a shallow slide caused by undercutting; settlement has carved into the crown; adjacent area was recently repaired for burrow den on the lower slope; recently placed rocks on adjacent repair site [2009 SiteID:NA0017U16RM4.57]

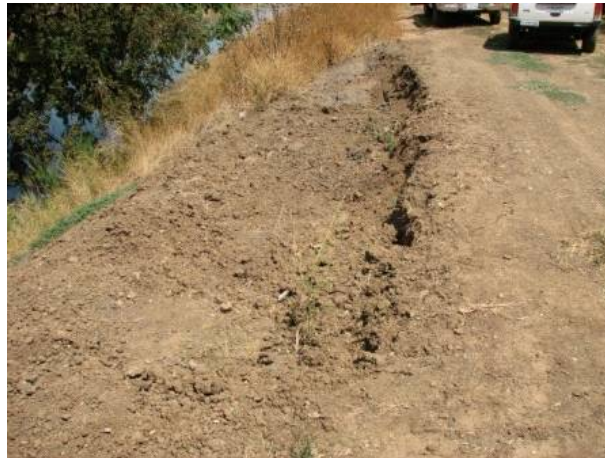
SJR2009_LM4.57U16 081209D.JPG

2009: Differential settlement of 1-2"; appears to be a shallow slide caused by undercutting; settlement has carved into the crown; adjacent area was recently repaired for burrow den on the lower slope; recently placed rocks on adjacent repair site [2009 SiteID:NA0017U16RM4.57]

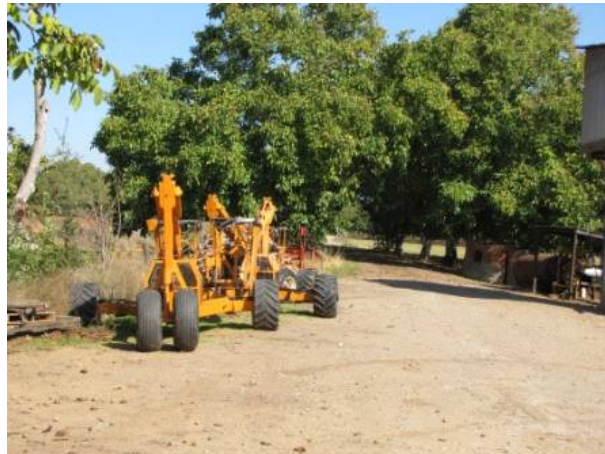
dpesaven_s_20100316_412.jpg

Levee Mile Report Line	22
Start Levee Mile	5.94
End Levee Mile	5.94
Location	Water Side
Category	Earthen Levee
Item	Encroachments

View of equipment located on the waterward side looking upstream.

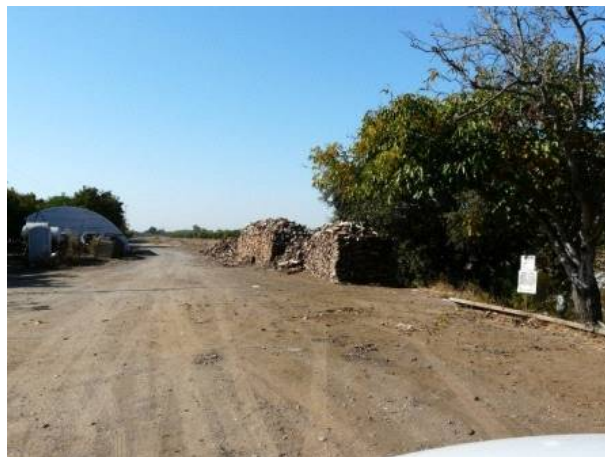
dpesaven_s_20100316_341.JPG

Levee Mile Report Line	23
Start Levee Mile	5.95
End Levee Mile	5.95
Location	Water Side
Category	Earthen Levee
Item	Encroachments

Firewood piles located on waterside of shoulder at LM 5.95. These piles should be moved away from landside of access road.

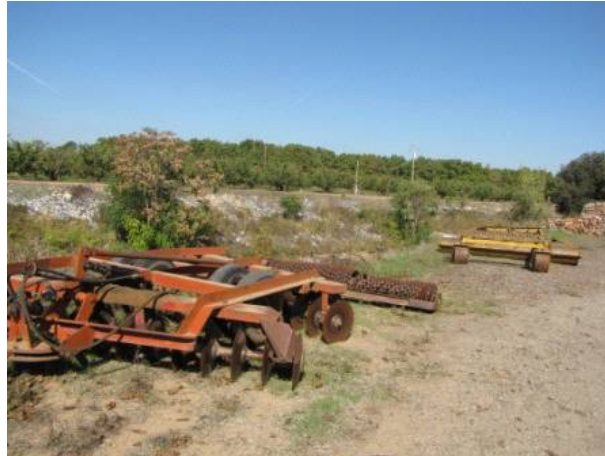
dpesaven_s_20100316_411.jpg

View of equipment located along the waterward side looking upstream.

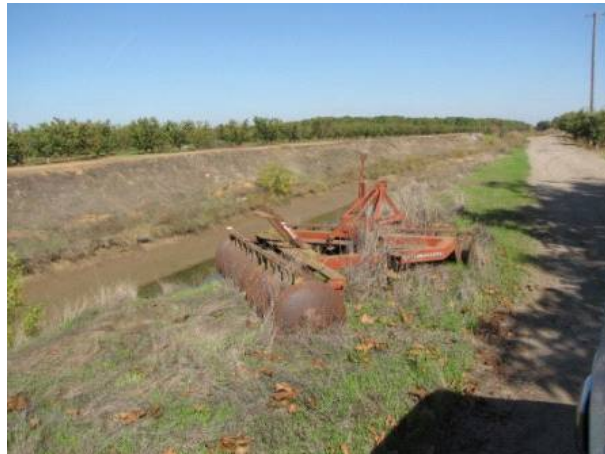
dpesaven_s_20100316_410.jpg

Levee Mile Report Line	25
Start Levee Mile	6.18
End Levee Mile	6.18
Location	Water Side
Category	Earthen Levee
Item	Encroachments

View of equipment on the waterward side looking upstream.

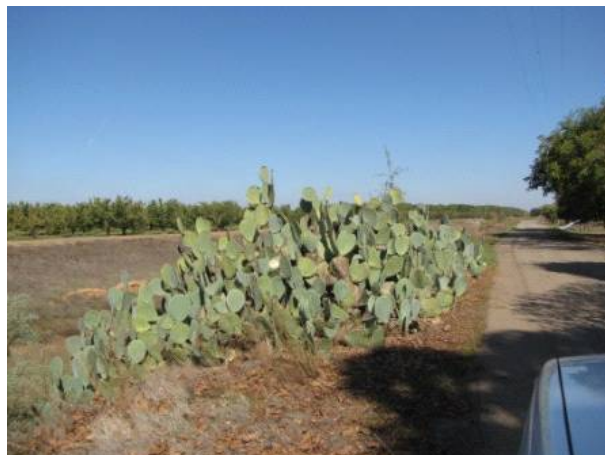
View of cacti located on waterward side looking upstream.

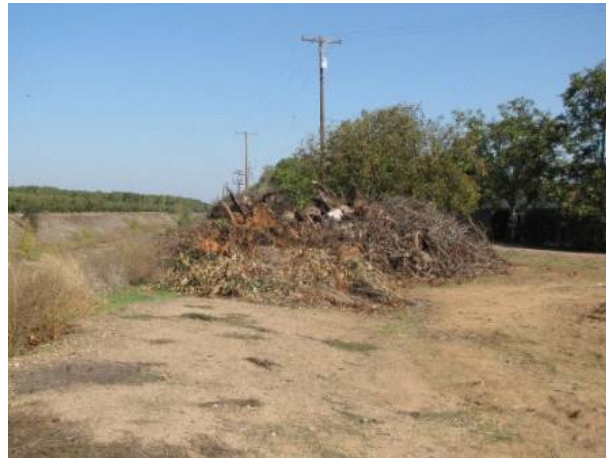
View of a large prunings pile on waterward side and access road blocking visibility and access looking upstream.

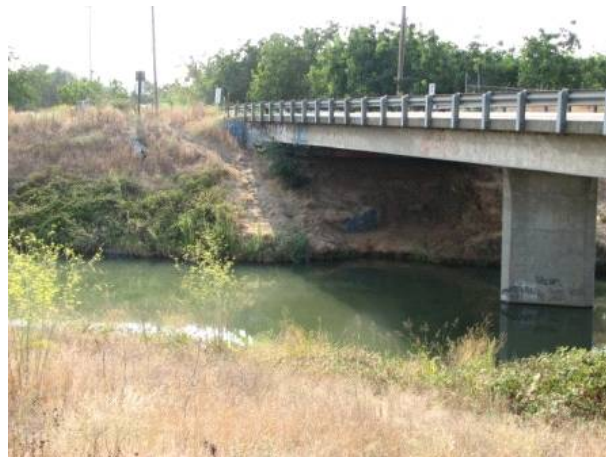
Levee Mile Report Line	29
Start Levee Mile	6.47
End Levee Mile	6.48
Location	Water Side
Category	Supplemental
Item	DWR Erosion Survey

2009: site is adjacent to abutment on Milton Road Bridge; pocket erosion has developed and will continue to expose the bridge foundation; this erosion appears to be critical as it may affect the bridge foundation [2009 SiteID:NA0017U16RM6.47]

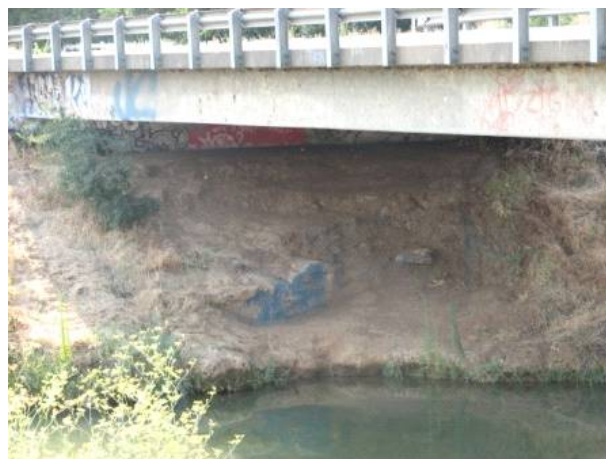
Levee Mile Report Line	29
Start Levee Mile	6.47
End Levee Mile	6.48
Location	Water Side
Category	Supplemental
Item	DWR Erosion Survey

2009: site is adjacent to abutment on Milton Road Bridge; pocket erosion has developed and will continue to expose the bridge foundation; this erosion appears to be critical as it may affect the bridge foundation [2009 SiteID:NA0017U16RM6.47]

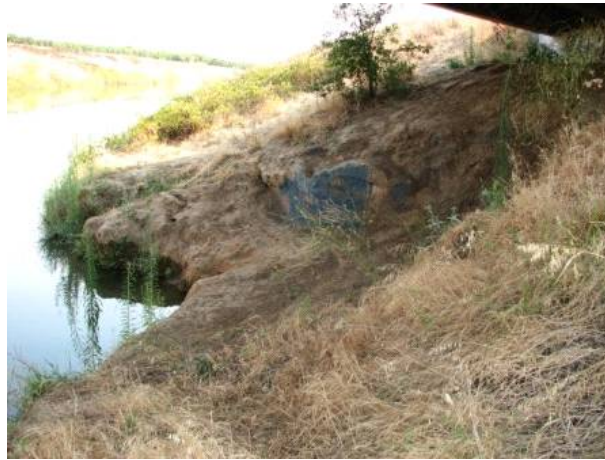
2009: site is adjacent to abutment on Milton Road Bridge; pocket erosion has developed and will continue to expose the bridge foundation; this erosion appears to be critical as it may affect the bridge foundation [2009 SiteID:NA0017U16RM6.47]

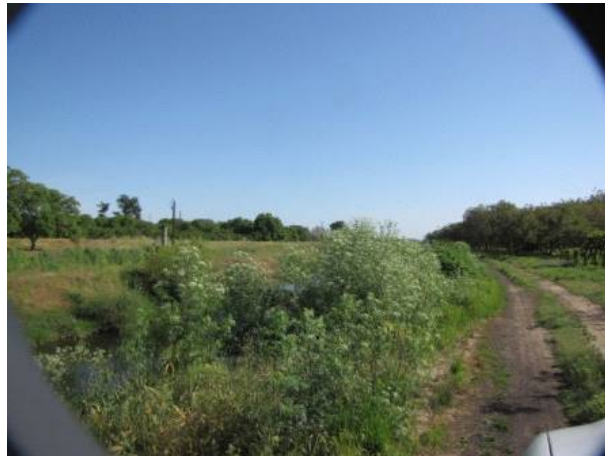
Levee Mile Report Line	30
Start Levee Mile	6.63
End Levee Mile	6.74
Location	Water Side
Category	Earthen Levee
Item	Vegetation

View of vegetation blocking visibility on the waterward shoulder of the access road looking upstream.

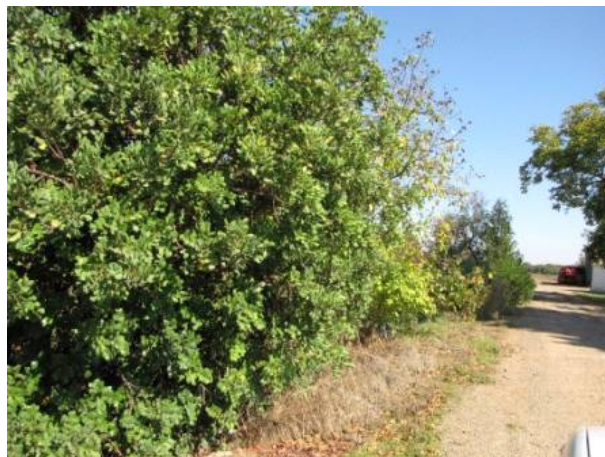
Levee Mile Report Line	31
Start Levee Mile	6.99
End Levee Mile	7.02
Location	Water Side
Category	Earthen Levee
Item	Encroachments

View of landowner planted and maintained landscaping and vegetation along the waterward side looking upstream.

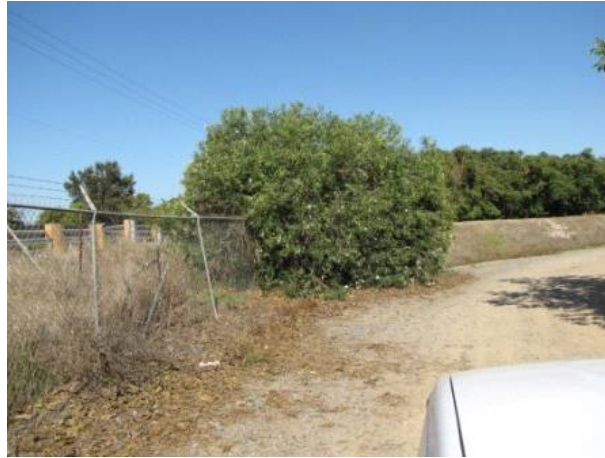
View of an oleander bush along the waterward side obstructing access and visibility.

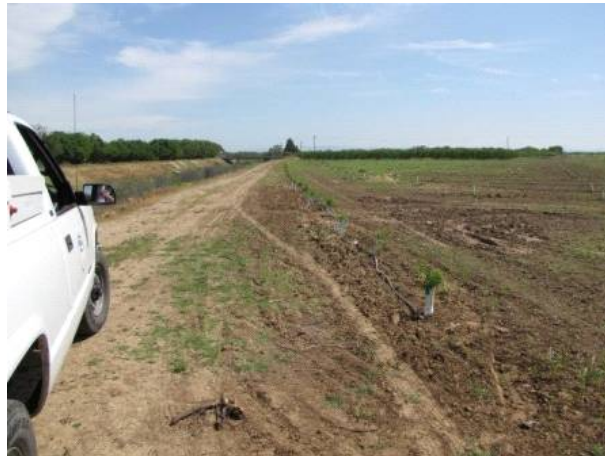
Levee Mile Report Line	34
Start Levee Mile	7.11
End Levee Mile	7.29
Location	Land Side
Category	Earthen Levee
Item	Encroachments

Recently planted trees are within 10' of landward toe of levee. These trees are an encroachment and are potentially future maintenance issues.

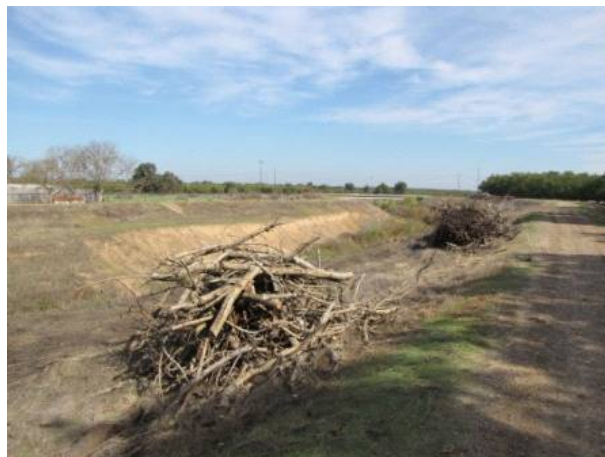
Levee Mile Report Line	43
Start Levee Mile	8.46
End Levee Mile	8.46
Location	Water Side
Category	Earthen Levee
Item	Encroachments

View of pruning piles located on waterward side looking upstream.

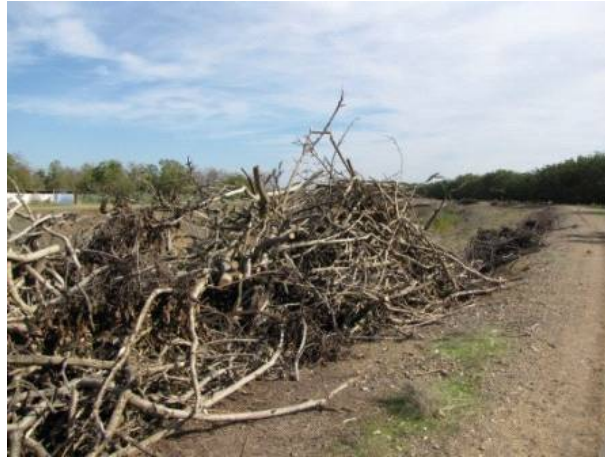
View of prunings located on waterward side looking upstream.

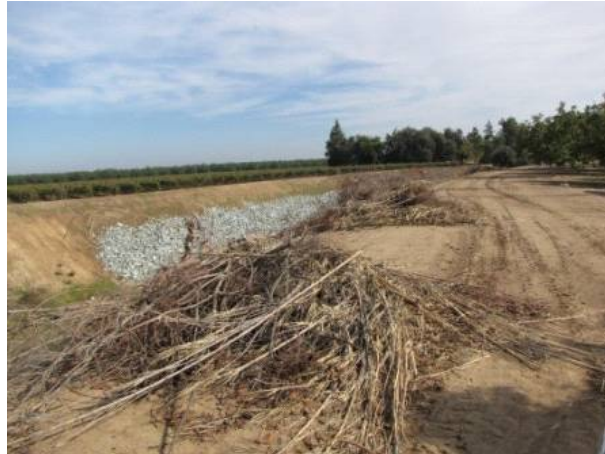
Levee Mile Report Line	47
Start Levee Mile	9.01
End Levee Mile	9.01
Location	Water Side
Category	Earthen Levee
Item	Encroachments

View of prunings piles located on waterward side looking upstream.

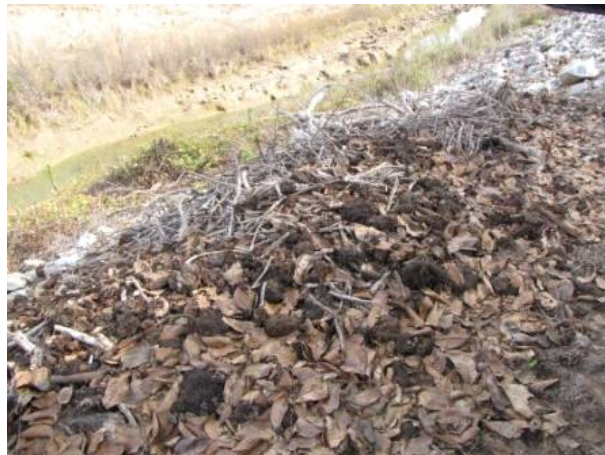
Levee Mile Report Line	50
Start Levee Mile	9.99
End Levee Mile	9.99
Location	Water Side
Category	Earthen Levee
Item	Encroachments

View of prunings on waterward side looking upstream.

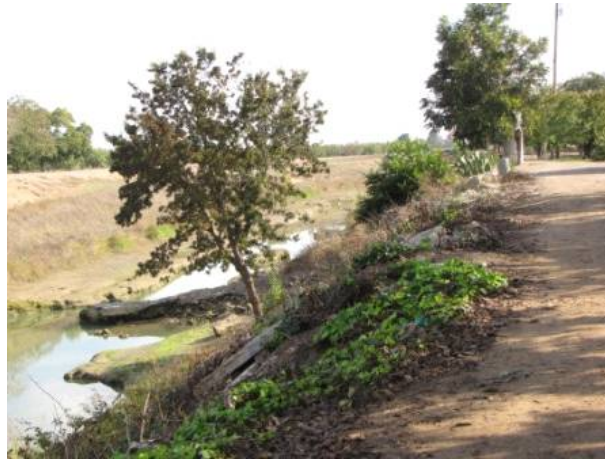
View of landscaping on waterward side looking upstream.

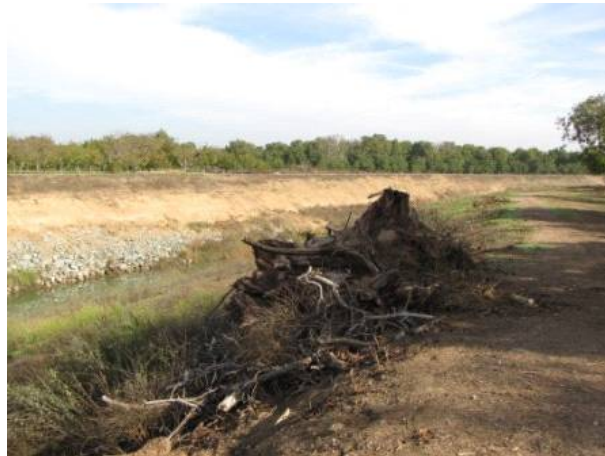
Levee Mile Report Line	55
Start Levee Mile	11.07
End Levee Mile	11.07
Location	Water Side
Category	Earthen Levee
Item	Encroachments

View of prunings located on waterward side looking upstream.

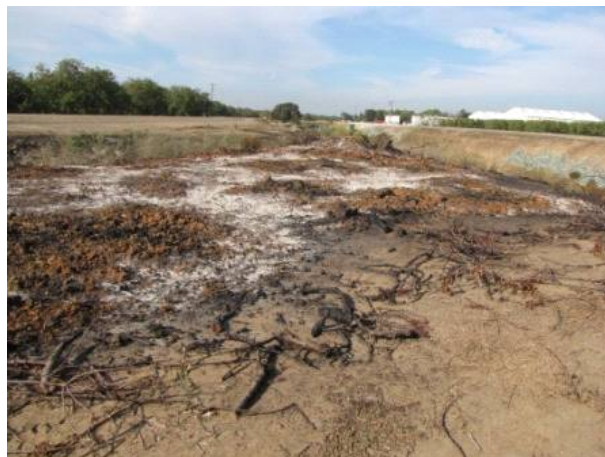
Levee Mile Report Line	58
Start Levee Mile	11.41
End Levee Mile	11.41
Location	Water Side
Category	Earthen Levee
Item	Encroachments

58	11.41	11.41	Earthen Levee	Encroachments	WS	M	Prunings Inspector Comments: Pile has been burned, but some prunings remain. Farmer needs to stop burning at this location as the ground is getting baked.	37.960557 ° -121.163432 °	37.960557 ° -121.163432 °	89 Y
59	11.51	11.51	Earthen Levee	Encroachments	WS	M	Debris Inspector Comments: Concrete tile and other concrete debris illegally dumped on the waterward berm. Remove material and prevent additional material from being dumped.	37.960292 ° -121.165191 °	37.960292 ° -121.165191 °	155
60	11.52	11.59	Earthen Levee	Encroachments	WS	PO	Equipment	37.960282 ° -121.165380 °	37.960118 ° -121.166580 °	88 Y

View of location where prunings were burned on waterward side and access road looking downstream.

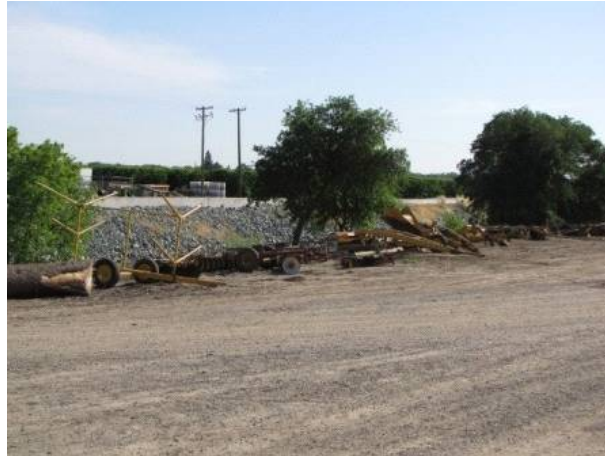
Levee Mile Report Line	60
Start Levee Mile	11.52
End Levee Mile	11.59
Location	Land Side
Category	Earthen Levee
Item	Encroachments
Remove equipment from waterward side of levee.	
dpesaven_s_20100316_343.jpg

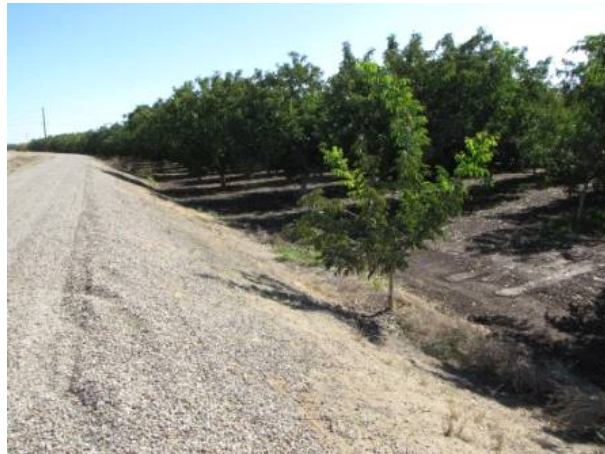
Levee Mile Report Line	65
Start Levee Mile	12.80
End Levee Mile	12.80
Location	Land Side
Category	Earthen Levee
Item	Encroachments
View of a tree planted at the landward toe looking upstream. This tree appears to be planted by the farmer.	
dpesaven_s_20100316_393.jpg

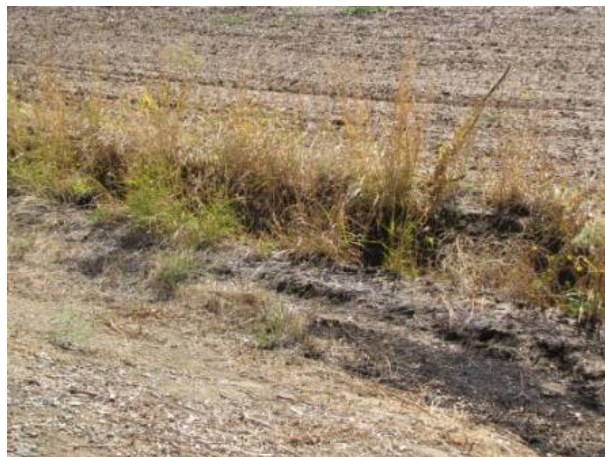
Levee Mile Report Line	66
Start Levee Mile	12.96
End Levee Mile	13.16
Location	Land Side
Category	Earthen Levee
Item	Encroachments
View of an irrigation/drainage ditch along the landward toe.	
dpesaven_s_20100316_392.jpg

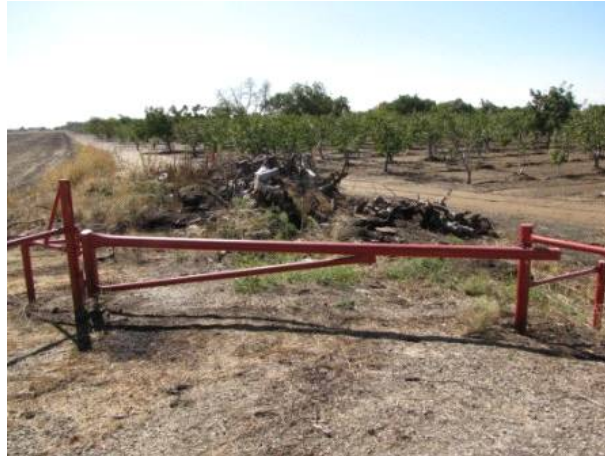
View of a prunings pile along the landward toe of an access ramp. Pile is blocking access through this gate.

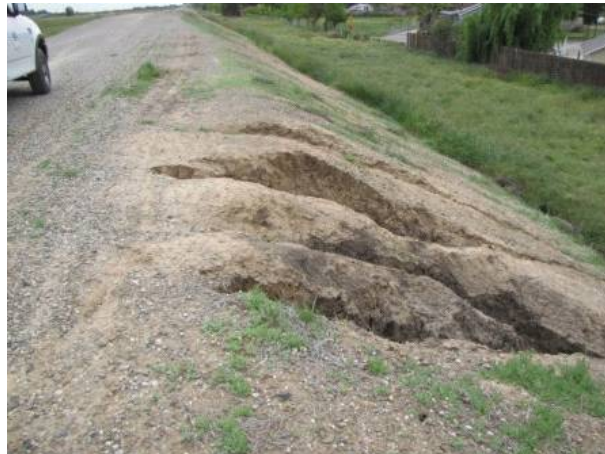
Levee Mile Report Line	73
Start Levee Mile	14.74
End Levee Mile	14.74
Location	Land Side
Category	Earthen Levee
Item	Erosion / Bank Caving

View of erosion occurring on the landward slope looking upstream.

72	14.47	14.47	Earthen Levee	Encroachments	LS	M	Tree or limb	37.965874 ° -121.214986 °	37.965874 ° -121.214986 °	74
73	14.74	14.74	Earthen Levee	Erosion / Bank Caving	LS	M	Schedule repair of erosion site prior to the next inspection.	37.967976 ° -121.219120 °	37.967976 ° -121.219120 °	73 Y
74	15.89	15.98	Earthen Levee	Vegetation	WS	M	Control annual grass and weeds on the levee slopes and easements.	37.976052 ° -121.237157 °	37.976648 ° -121.238591 °	72
75	16.15	16.15	Earthen Levee	Crown Surface / Depressions / Rutting	CR	M	Regrade the crown roadway for proper drainage.	37.977762 ° -121.241241 °	37.977762 ° -121.241241 °	71

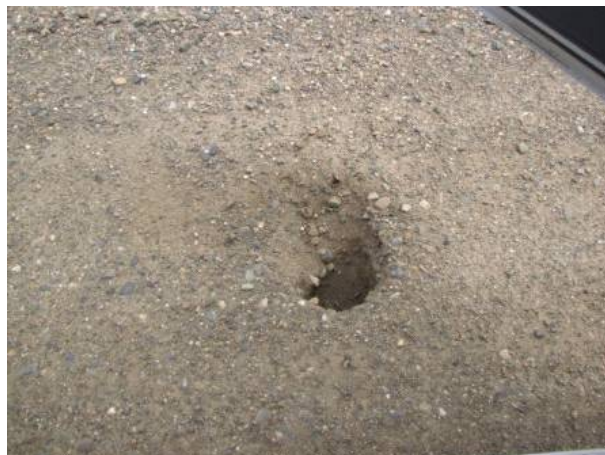
Levee Mile Report Line	76
Start Levee Mile	16.58
End Levee Mile	16.58
Location	Crown
Category	Earthen Levee
Item	Crown Surface / Depressions / Rutting

View of a depression in the crown of the levee.

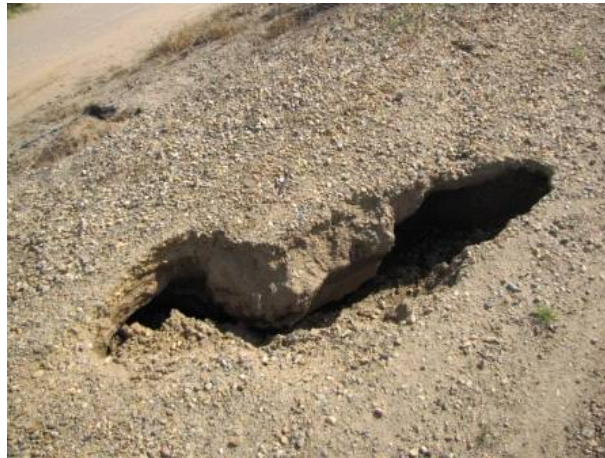
View of a cavity in the ramp adjacent to the waterward side of the levee.

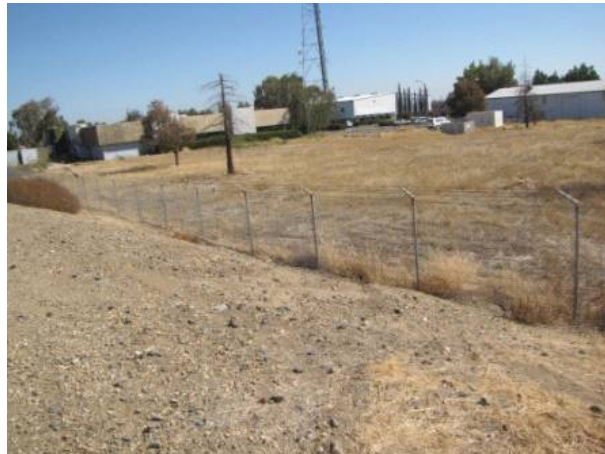
Levee Mile Report Line	82
Start Levee Mile	19.00
End Levee Mile	19.20
Location	Land Side
Category	Earthen Levee
Item	Encroachments

View of a fence along the landward toe looking upstream.

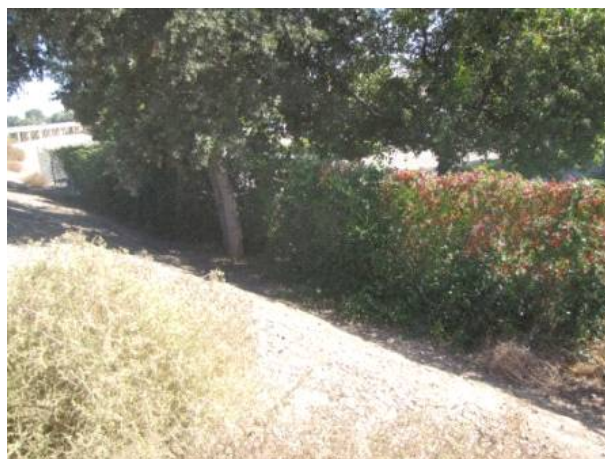
Levee Mile Report Line	84
Start Levee Mile	19.12
End Levee Mile	19.14
Location	Land Side
Category	Earthen Levee
Item	Encroachments

View of landscaping along the landward toe.

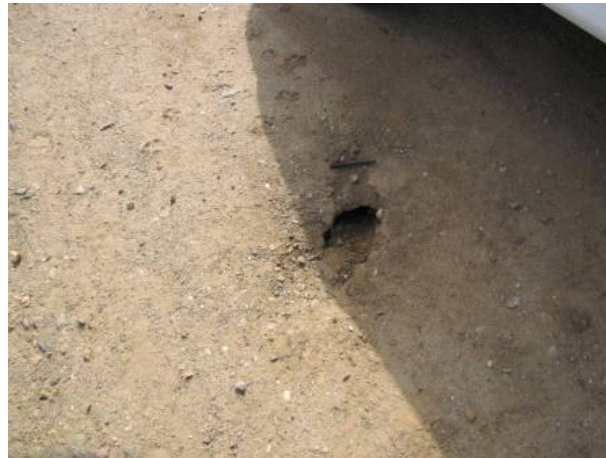
View of a rodent hole in the crown of the levee.

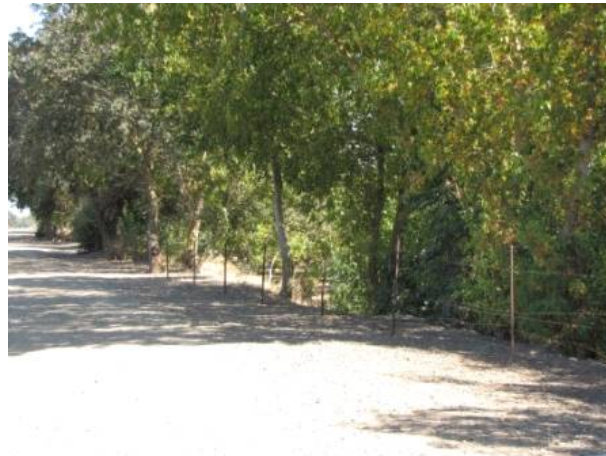
Levee Mile Report Line	89
Start Levee Mile	19.47
End Levee Mile	19.60
Location	Land Side
Category	Earthen Levee
Item	Encroachments

View of a barbed wire fence and landscaping along the landward shoulder and slope looking upstream.

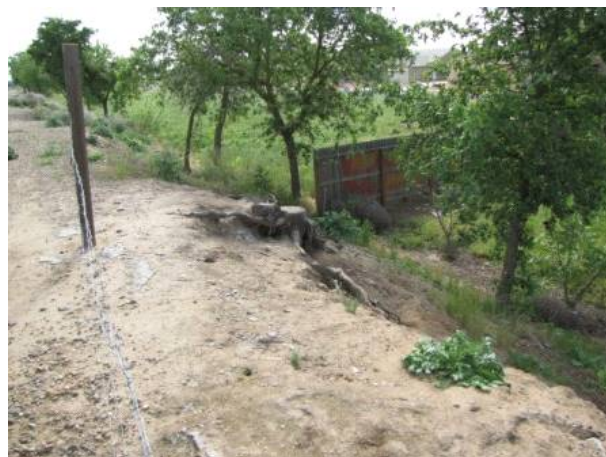
Levee Mile Report Line	91
Start Levee Mile	19.48
End Levee Mile	19.48
Location	Land Side
Category	Earthen Levee
Item	Trim / Thin Trees

View of a stump on the landward slope looking upstream.

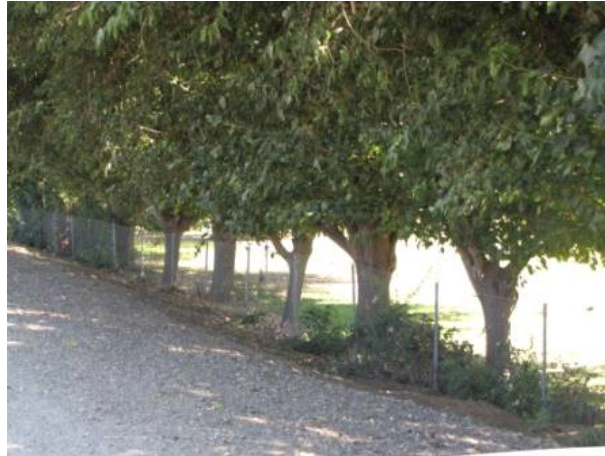
View of a fence along the landward slope looking upstream.

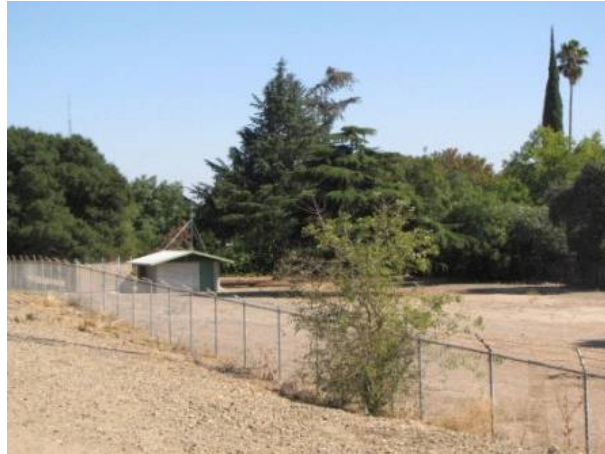
Levee Mile Report Line	97
Start Levee Mile	19.82
End Levee Mile	19.90
Location	Land Side
Category	Earthen Levee
Item	Encroachments

View of a fence along the landward toe looking upstream.

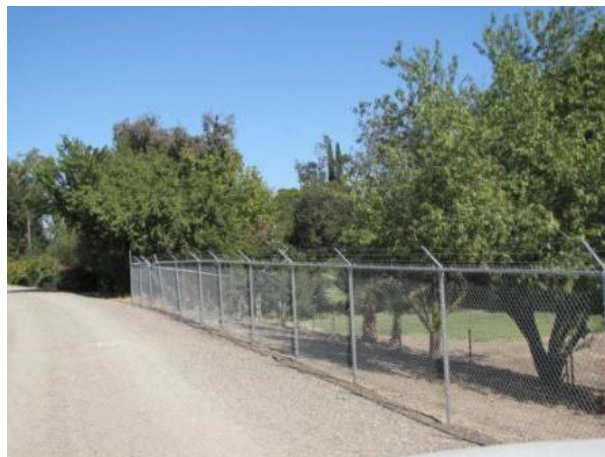
Levee Mile Report Line	114
Start Levee Mile	20.26
End Levee Mile	20.28
Location	Land Side
Category	Earthen Levee
Item	Encroachments

View of a fence along the landward slope looking upstream.

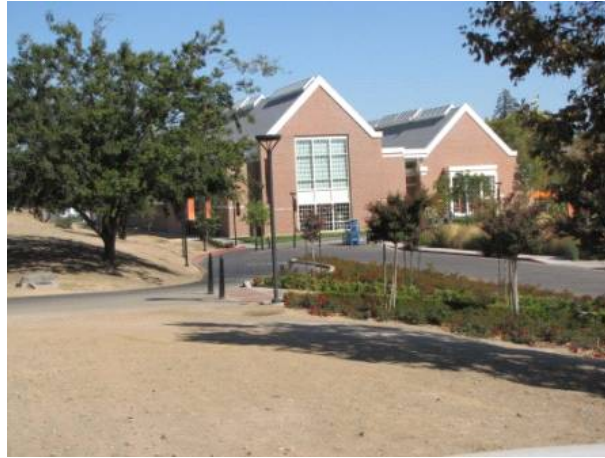
View of landscaping planted and maintained by UOP along the landward slope and toe looking upstream.

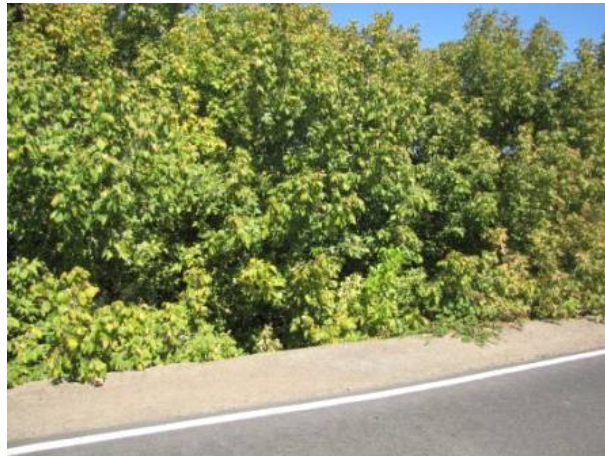
Levee Mile Report Line	139
Start Levee Mile	22.03
End Levee Mile	22.03
Location	Water Side
Category	Earthen Levee
Item	Trim / Thin Trees

View of trees along the waterward slope obstructing visibility and access.

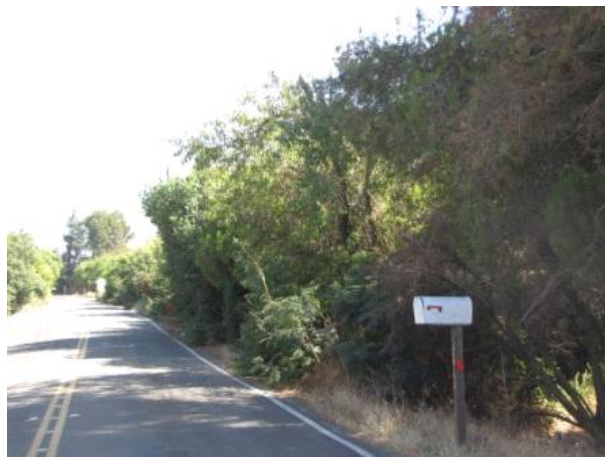
Levee Mile Report Line	144
Start Levee Mile	22.17
End Levee Mile	22.37
Location	Land Side
Category	Earthen Levee
Item	Encroachments

View of landscaping along landward slope looking upstream.
